Dome Sweet Dome - Part 2

In 2001 I agreed to write a short article on my adventures building an observatory on top of my garage and installing a second-hand 9-foot dome. The article ended with a delay in finding a supply of fibreglass matting, and the completion being put off till spring 2002.

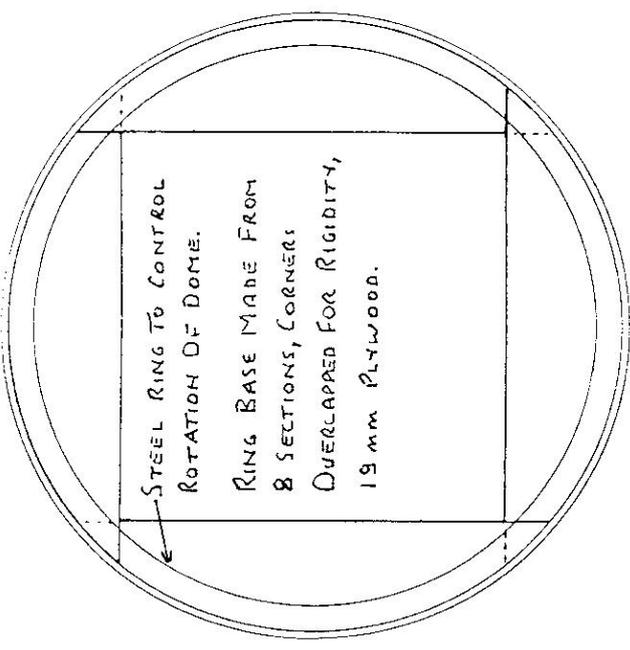
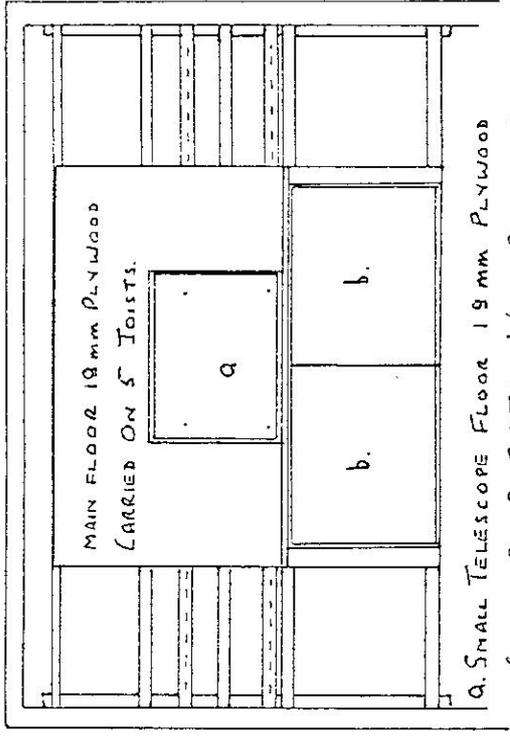
SECTION ON X - X

SECTION ON Y - Y

a. SMALL TELESCOPE FLOOR 19 MM PLYWOOD CARRIED ON 2 RST'S WITH PACKING TO REDUCE VIBRATION.

b. TRAP DOORS TO GAIN ACCESS FROM GARAGE VIA ALUMINIUM LADDER.

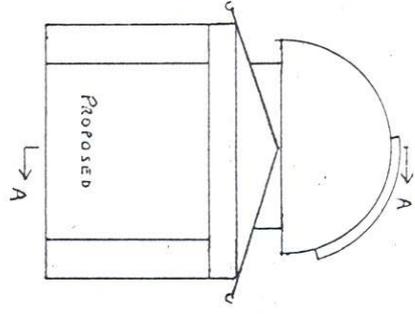
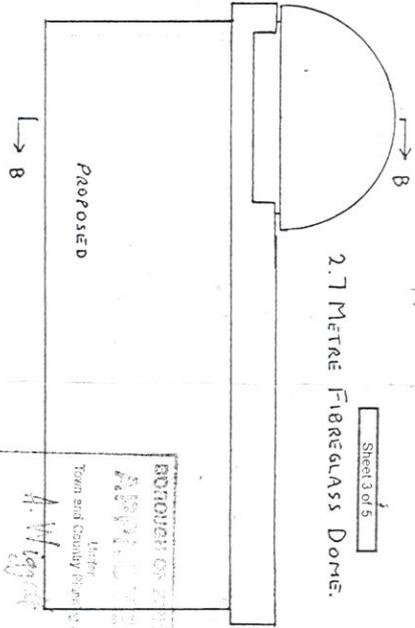
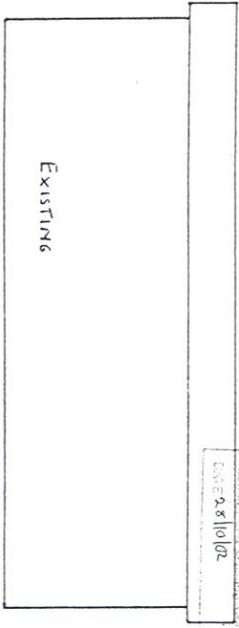
Sheet 3 of 5

2.7 METRE FIBREGLASS DOME.

EXISTING AND PROPOSED
 ELEVATIONS AND PLAN.
 GARAGE WALLS 150mm
 THICK HOLLOW CONCRETE
 BLOCKS.
 ROOF OF 19mm PLYWOOD
 WITH PLASTIC COATED
 STEEL OVER.
 SCALE 1:50.
